# Static Response of a Group of 13 Piles Tested Simultaneously

**Abstract.** Static loading tests to plunging "failure" were performed on a single pile and a group of 13 piles in a loose to compact silty sand. The piles were 300-mm diameter, 9.5 m long, bored piles with an expanded pile toe, a 400 mm wide Expander Body (EB). Each pile had a bidirectional cell place just above the EB. All pile heads were free. The tests comprised a bidirectional test on the piles with the pile group cells activated via a common pressure pump, thus, ensuring that equal load was applied to all piles, allowing each pile to move individually. The pile group responded as a pier with shaft resistance equal to the shear along its side rather than as 13 single piles.

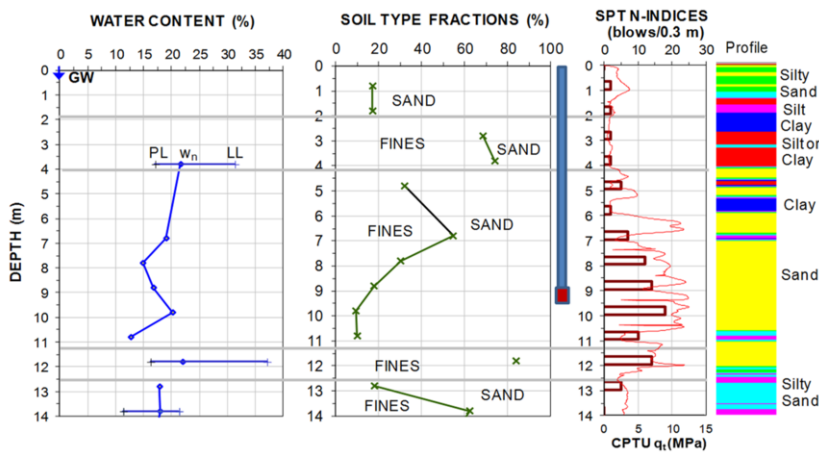
Figure 1. Soil profile from BH-E2.

pressure. Figure 1 shows a diagram compiling borehole information, SPT  $N$ -indices, and the CPTU cone stress,  $q_t$ , to 14 m depth. The CPTU was pushed to 22 m depth and Figure 2 shows all the results.

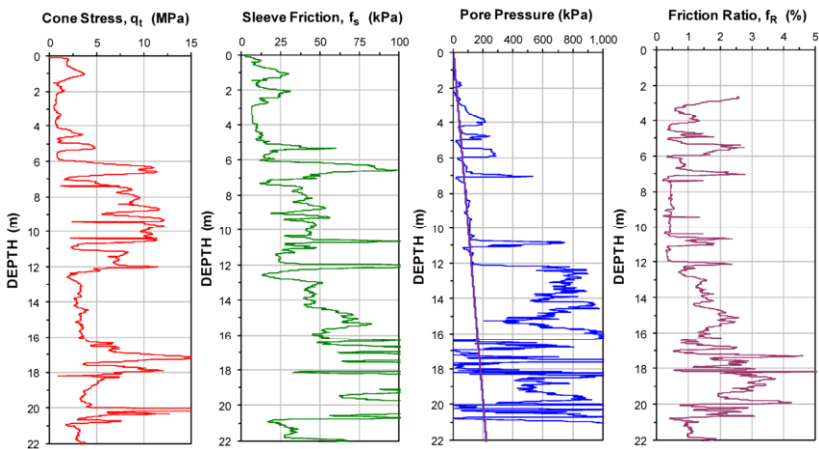
Figure 2. CPTU sounding diagram, CPTU E2.

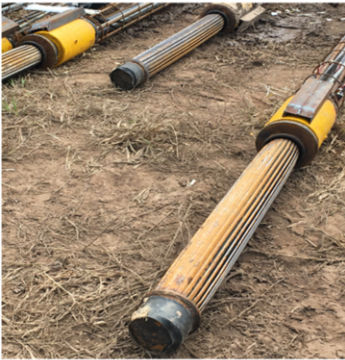
**Figure 3.** Photo of the EBs and BD before pile construction.

The Expander Body and its use is described by Terceros and Massarsch (2014). Figure 3 shows a photo of the Expander Body and BD Yellow unit) before insertion into the pile shaft. The BD is connected to the pile reinforcement cage. The location of the separation of the BD and cage from the EBI was designed to occur at the bottom of the BD.

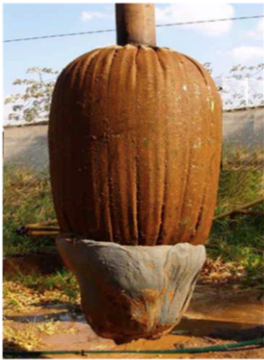
**Figure 4.** Exhumed EB.

Figures 4 and 5 show photos of an exhumed EBI and one expanded in air (model IDs EBI612 and EBI815, respectively, with the numbers indicating the diameter of a freely expanded unit. Figure 4 shows a photo of an exhumed EBI (EBI612) with post-expansion grout material and an in-air expanded EBI (EBI815). The grout volumes and injection pressures used for the expansion of the EBIs of the 14 test piles were very similar for the piles. The averages were 102 L and 4.0 MPa, respectively.

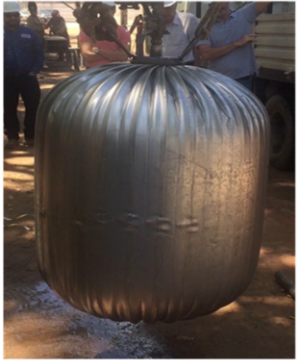
**Figure 5.** in-air expanded EB

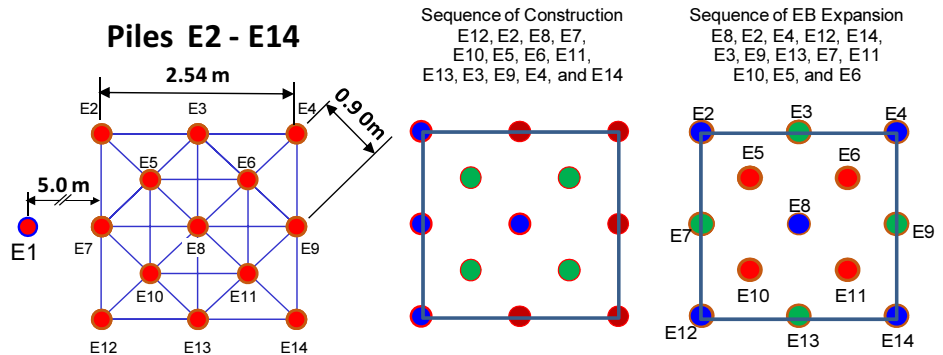
**Figure 6.** Pile locations and sequence of construction and EB expansion.

The piles were installed at a 3 pile-shaft diameter, center-to-center spacing, 0.90 m in the configuration shown in Figure 6. The spacing corresponds to an 11 % total footprint ratio (nominal total pile area over group footprint area excluding the EBI area).

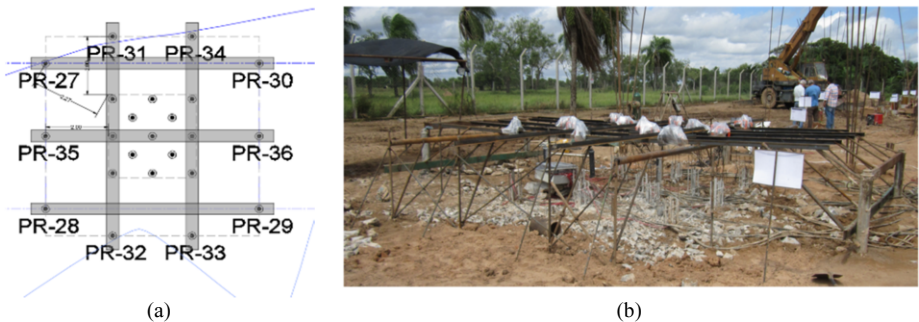
**Figure 7.** (a) General arrangement of at the test, showing reaction piles and beams; (b) Frame for recording pile movements Phase I test on Piles E2 - E14.

Static loading tests were performed on the piles—the single pile and group piles—by engaging the BD cell to push the pile shaft upward with the EB providing the necessary reaction force. The BD cells in the group piles were connected to the same pump to have all group piles, Piles E2 - E14, activated with equal load per pile. The pile heads were unrestrained and the pile head movements were measured individually. Figure 7.a shows the general arrangement with beams and reaction piles locations and Figure 7.b shows a photo of the arrangement for recording the individual movements of the piles. The measurements included monitoring the ground surface movements at 10 points along the perimeter and in the interior area of the group.

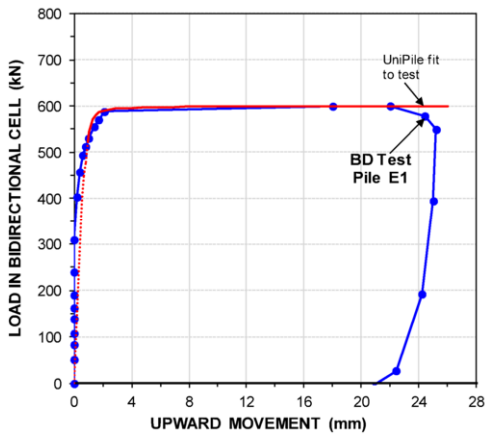
Figure 8. Pile E1 Upward load-movement of the pile length above the BD.

Figure 8 shows the measured load-movement of the upper pile length, plotted in accordance with the reporting convention of bidirectional testing as load vs. movement. The pile response to the applied BD load was quite stiff with very small movement up to 500 kN applied load at about 1 mm movement, which indicates the presence of residual compression force in the pile at the start of the test. Beyond 600 kN load and 2 mm movement, the response went into plunging. The figure also shows the result of a fit to the measured curve per an effective stress analysis and a hyperbolic t-z function with a function coefficient of 0.0099 ( $1/Q_{100\%}$ ). The effective stress proportionality beta-coefficient, as applied to 1.0 m pile elements, ranged from  $\beta = 0.4$  at the ground surface to  $\beta = 2.0$  at 6 m depth, which value was then kept to the BD depth. The UniPile5 software (Goudreault and Fellenius 2014) was used to back-calculate the pile response.

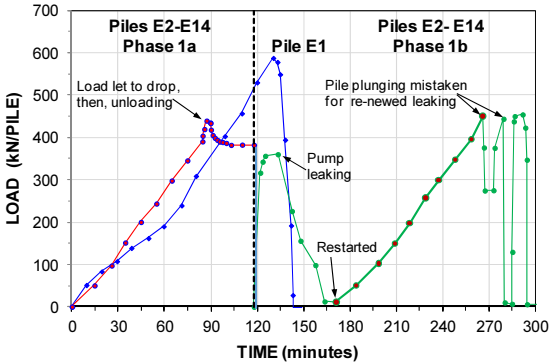
Figure 9. Loading sequence for Pile E1 and Piles E2 - E14.

**PILES E2 - E14.** The static loading test on the pile group, Piles E2 - E14 started on April 25, 2017, applying the same schedule of loading as used for the single pile test, Phase 1a. Nine load increments into the test, it was realized that the data collector was not recording properly and this triggered an unloading of the test to restart with a functioning collector. Unfortunately, on reaching zero BD load, the cells were let to drain further, which allowed the remaining force in the pile to move the upper BD plate against zero force. The test was then restarted three days later from zero BD load and with zeroing of all gages. Figure 9 shows the load/pile versus time applied. The load-movement measured for Pile E1 is included. Shortly after re-starting the test, it was found that the pump had sprung a leak preventing it from maintaining pressure. The BDs were then unloaded to almost zero pressure, whereupon they were locked from further release of hydraulic pressure and the pump was repaired. The re-loading was performed with the same reference of load and movements as at the start of Phase 1b.

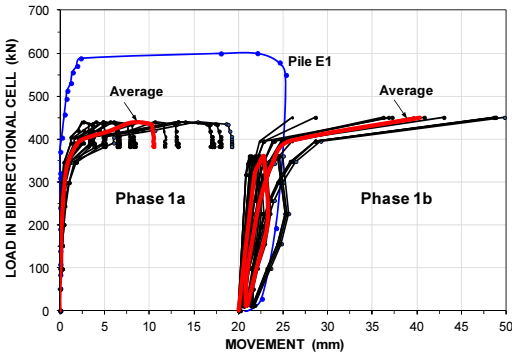
Figure 10. Pile E1 and Piles E2 - E14. Pile head upward load-movements.

Figure 10 shows the Piles E2 - E14 load-movements. The response of the 13 piles was very similar to that of the single pile: initially quite stiff and plunging after just a few millimetre of movement. However, the plunging load per pile was only about 70 % of the plunging load measured for Pile E1—430 kN versus 600 kN.

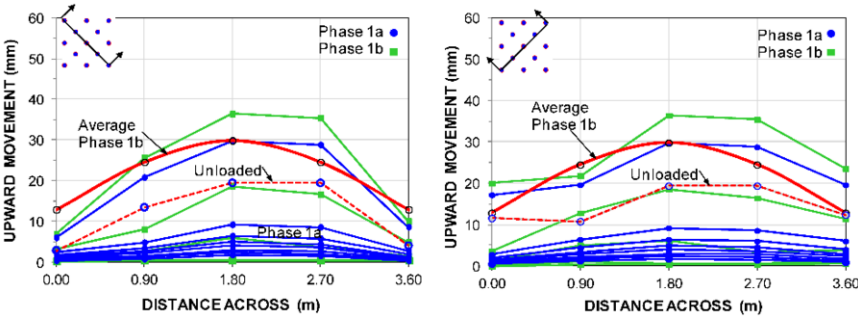
Figure 11. Upward movement of the pile heads along the diagonals, Phases 1a and 1b.

Figure 11 shows the upward movement of all pile heads across the two diagonals, including the net movements after Phase 1b unloading. Both graphs include the average of all pile head movements measured in Phase 1b for the maximum load, i.e., average of four piles, but for the center pile. The measurements showed that the center pile moved about three times more than the perimeter pile.

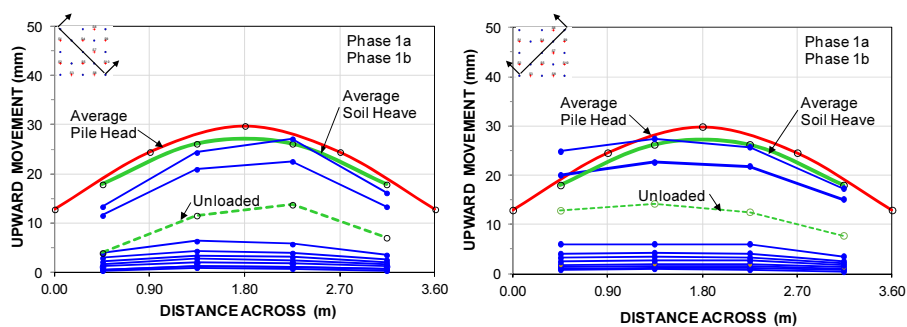
Figure 12. Upward movement of the ground surface within the pile group. Phase 1b.

Figure 12 shows the ground-surface upward movements across the diagonals (including net movements after Phase 1b unloading) and average (at maximum load) ground surface heave, as measured in ten anchors for Phase 1b. The figures repeat the average (at maximum load) upward movement of the pile heads (c.f., Figure 11). The "zero" measurement is the start of the Phase 1b, the net effect of Phase 1a is not known. It would seem that the pile heads moved a bit more than the soil surface. However, this is misleading because the pile head movements in Phase 1a in unloading were not recorded and, as mentioned, the Phase 1a ground surface measurements were not collected by the data collector. That is, the movements of the pile heads and the ground surface at the start of Phase 1b are unknown. The trend of the ground surface movements and that of the pile heads are the similar. In unloading after Phase 1b maximum load, the unloading movements were about the same for the pile head and the ground surface. It would seem that the pile head and ground surface moved more or less in unison.

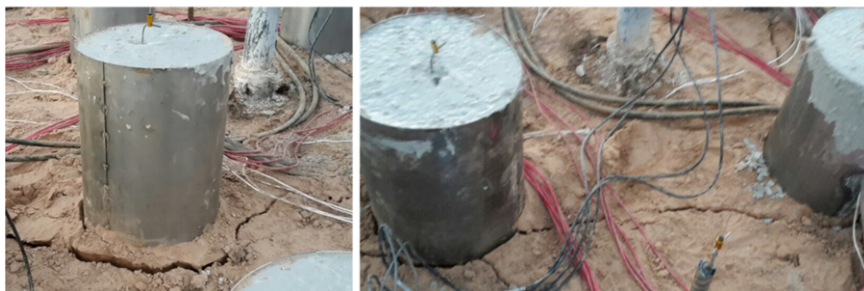
**Figure 13.** Photographs of cracks in ground surface at a corner pile and at two side piles.

Figure 13 and 14 are photographs of piles and ground taken after Phase 1b unloading and show cracks in the ground surface around a corner pile and from pile to pile along the perimeter of the group. The observations suggest that the pile group moved in unison encompassing piles and in-between soil.

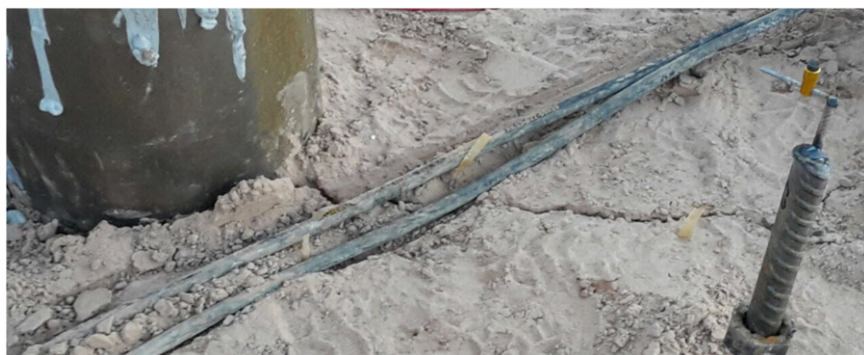
**Figure 14.** Photographs of cracks in ground surface stretching from one pile toward the next along the side of the group.
